AS- BUILT STRUCTURES

PASABAND, GHOR, AFGHANISTAN

SHINKOT CHC SITE PLAN

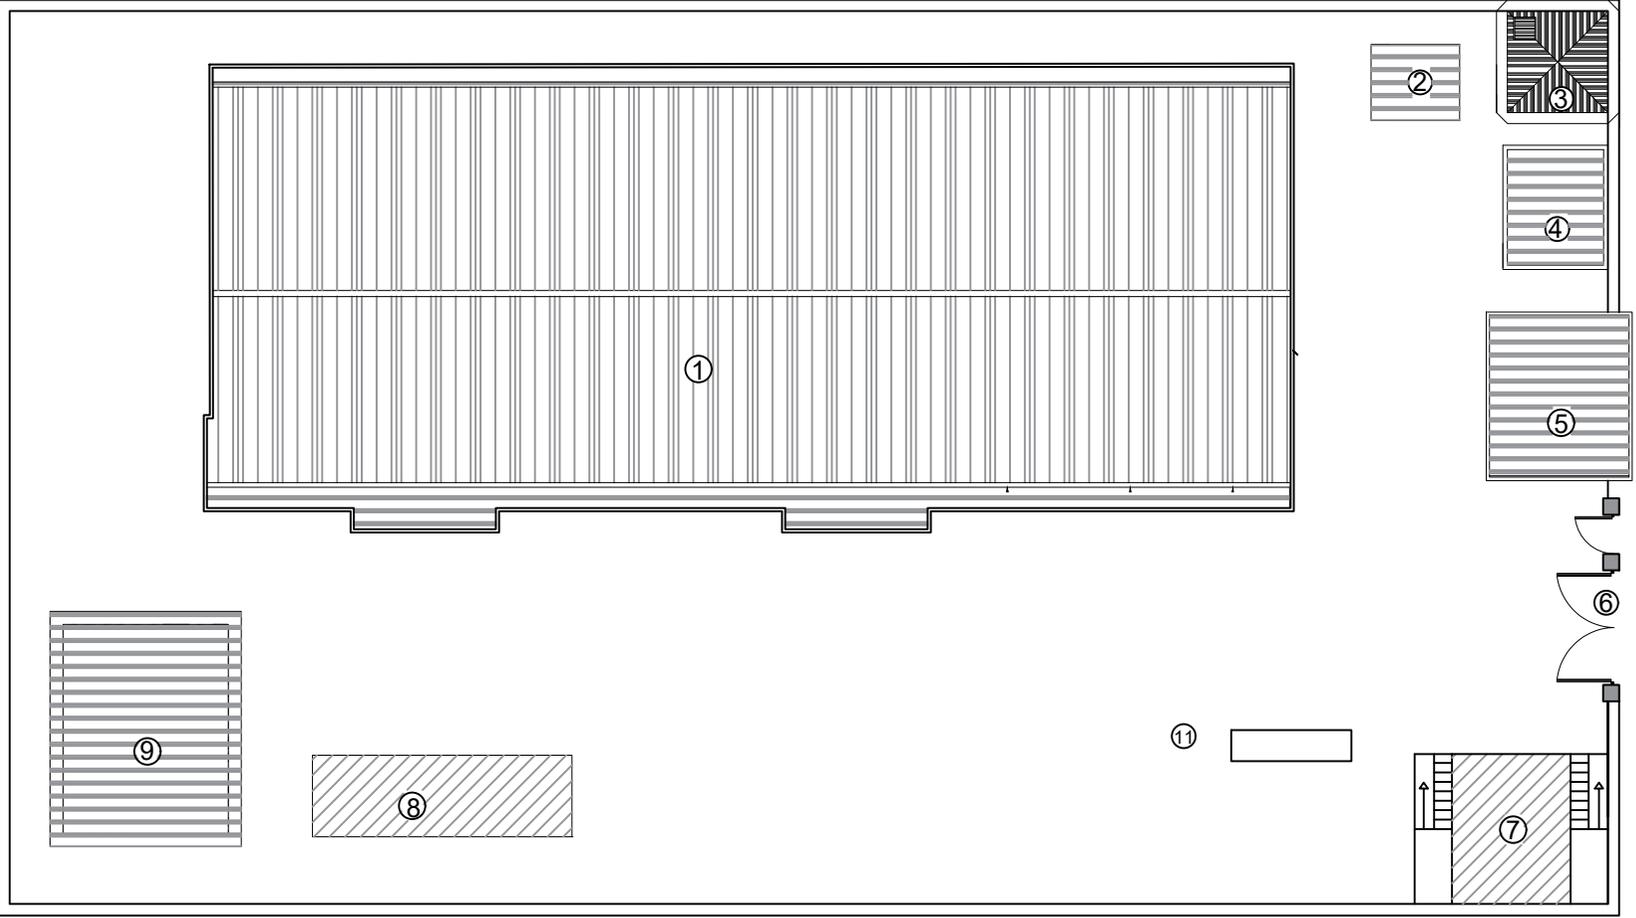
Identified Gaps in Existing WASH Services in Shinkot CHC:

- The building has plumbing system and waste water drain system, but the systems are damaged need to fundamental repairing.
- The existing toilets are damaged (floor tiles are broken, there is no flush tanks and there is not any stand WC for disabled people).
- The septic tank slab is broken and there is no drain pit next to the septic tank.
- There is hand washing sinks in the clinic rooms, but they are not connected to the water supply and drain system.
- The clinic doors are made of PVC material but the handles are damaged and they face problems during opening doors especially in the delivery room.
- There is no hand washing station in the clinic area

Solution:

- ActionAid plans to repair the water supply and waste water systems by connecting the hot and cold water from the water sources to the sinks and flash tanks and directing the waste water to the septic tank
- Rehabilitation of existing toilets by demolishing the floor by renewing the floors with new tiles and installing 2 stand WC's for male and other to female section for disabled people.
- Construction of the septic tank slab, drilling the drain pit and connecting of waste water to the septic tank.
- Connection of the hand washing sinks to the cold and hot water sources.
- Installation of the handles for the PVC doors.
- construction one public tap-station in clinic area for location and details (drawing)

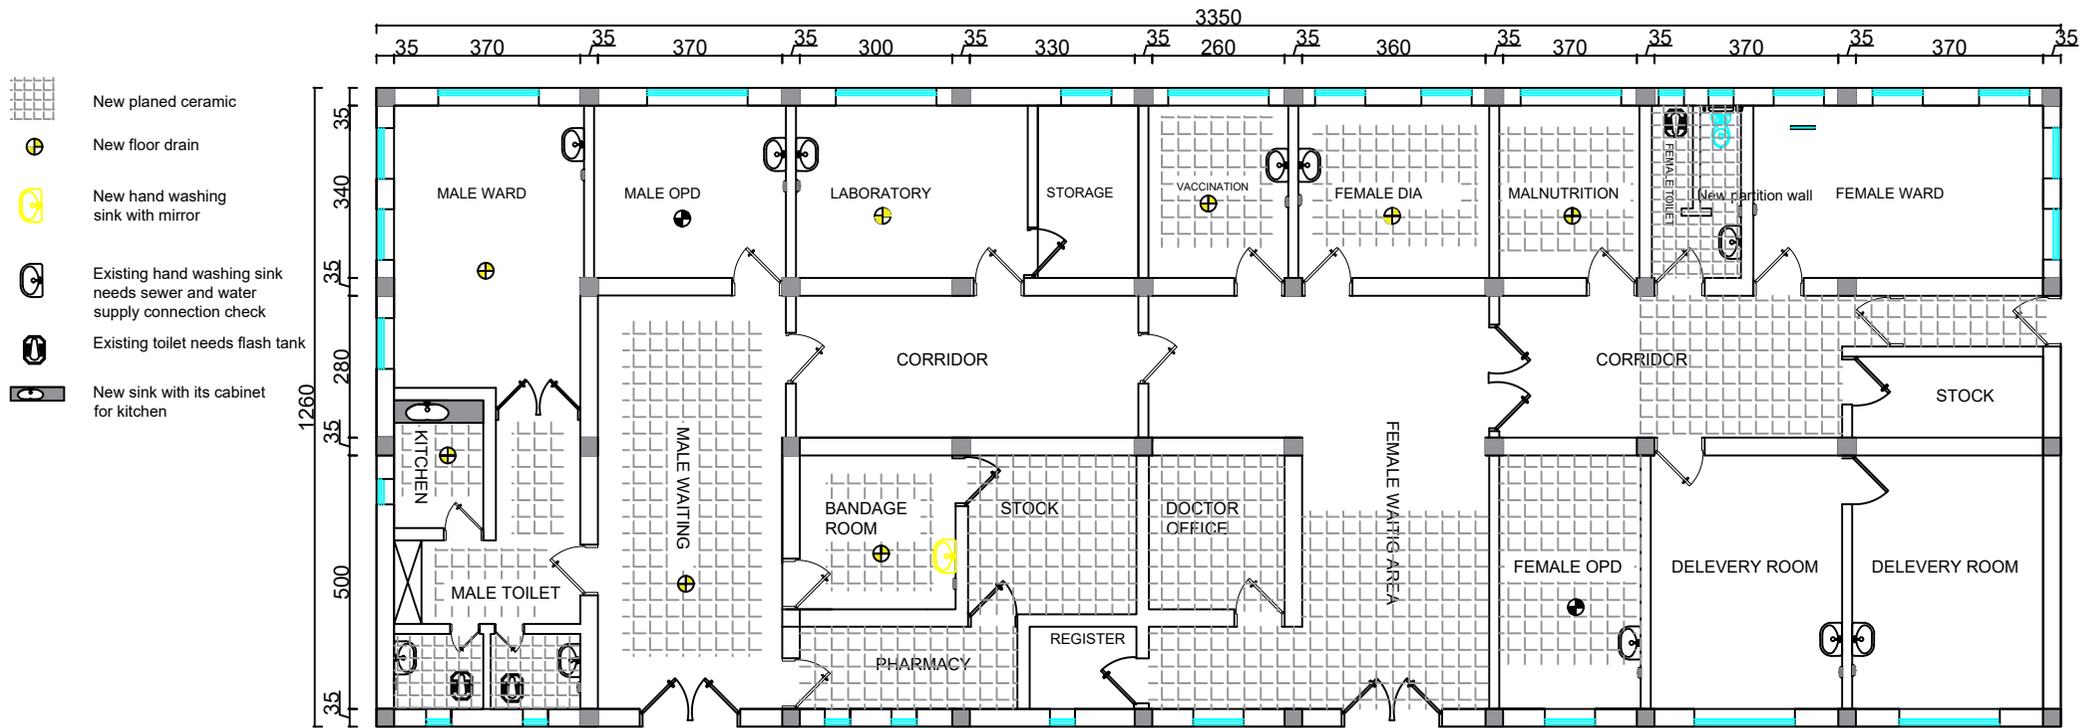
TABLE OF CONTENT	
1	Shinkot CHC building
2	Bore Well
3	Elevated Water Tank
4	Generator Room
5	Guard Room
6	Main Door
7	Dry Latrine
8	Septic Tank
9	Toilets
10	Incinerator
11	New Tap-Station

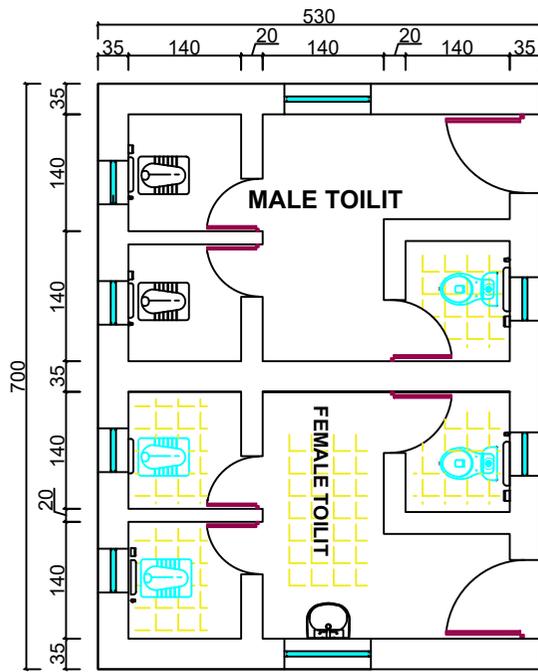
FLOOR PLAN FOR EXISTING TOILET

- The existing toilets floors need to be demolished and reconstructed with new tiles and need new flash tanks for the WC's
